United States Department of the Interior
National Park Service**National Register of Historic Places
Registration Form**

1. Name of Propertyhistoric name Jackson Township School Gymnasiumother names/site number Camden Elementary School Gymnasium of the Delphi Community School Corporation**2. Location**street & number 205 East Cumberland Street

Section number 7 Page 1 Jackson Township High School Gym in Camden, Carroll County, IN

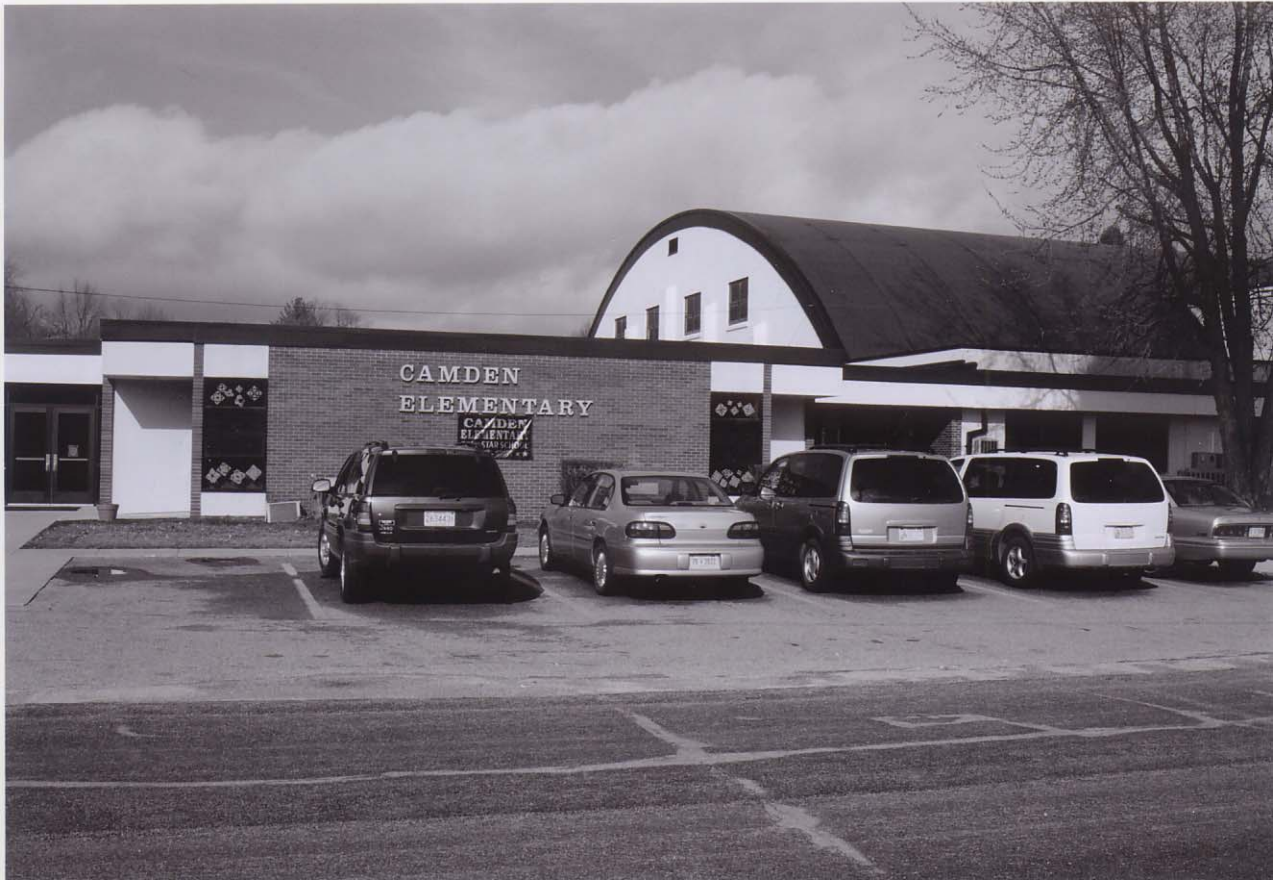
Photo 1

The Jackson Township High School Gymnasium in Camden, fronts on 205 East Cumberland Street between Water and Ohio Streets in Camden, Indiana (photos 1, 2 and 3). The gymnasium, a notable example of the late Art Deco period, is eligible for the National Register of Historic Places under Criteria A for its social significance and educational value to the Town of Camden and the residents of Jackson Township of Carroll County, Indiana.

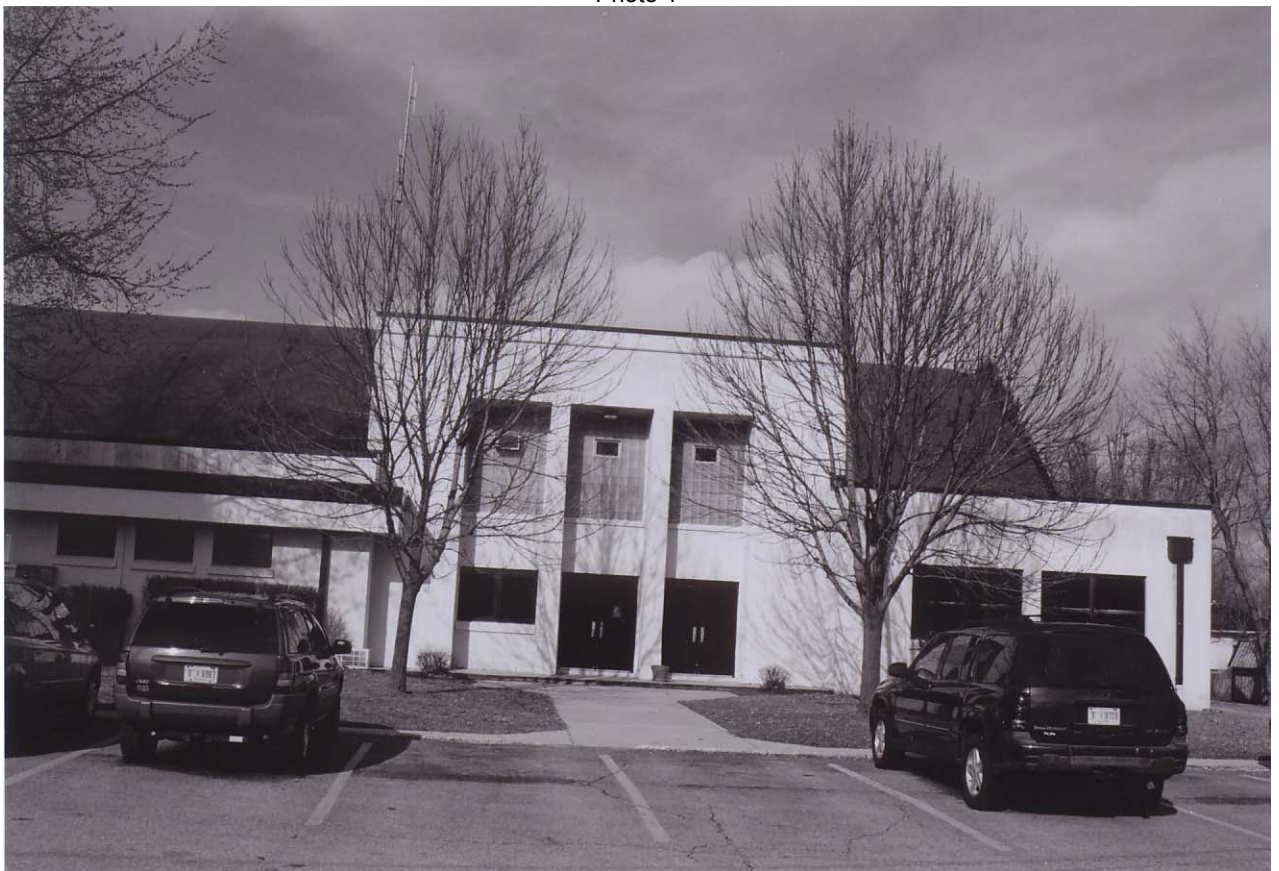
Photo 2

The main entrance to the building is also located on the south side. It consists of a three-part arrangement that runs the length of the gym. The two-story center bay features the entrance, which is accented by smooth concrete protruding pilasters. Glass block windows are inset in the bays on the second floor above each of the entrance doors. The western most entry door was replaced by steel casement windows (as part of the creation of an office). The original exterior doors were clear western pine and had solid wood panels with wood muntins and stops for the glass. The original doors have been replaced with new steel doors, one in the center bay, and one in the eastern bay. The cornice above the entrance has large stylized dentils that emphasize the Art Deco design (photo 2).

One-story bays flank the entrance bay. A series of three evenly spaced steel replacement windows are located to the left of the front entrance on the south elevation. These three small windows are on the upper portion of the wall and are overshadowed by a deep overhanging eave. A dark horizontal band runs the entire length of the eave and provides a strong horizontal emphasis to the gym. This horizontal band was continued over into the adjoining new school. The bay to the right of the front entrance features two large window openings. The original steel casement windows have been replaced by steel, one over one double windows. This window configuration is the common configuration for the replacement windows in the building. The entrance bay and both blanking bays have flat roofs that adjoin the barrel-vaulted roof of the gym (photo 2).

The main feature of the interior of the Jackson Township High School Gymnasium is barrel-vaulted ceiling (photo 2). There are four laminated wood arches supporting the roof, which were shipped to Camden from Portland, Oregon and installed by local contractors. According to one of the original workers, Curtis George, the arches were made from Douglas fir and graded in accordance with the WCLA (West Coast Lumberman's Association) Grading rule Number 14. In 1923, the WCLA, along with other regional limber associations, formed the first national committee for limber standardization on the auspices of the U.S. Department of Commerce. At the time Rule 14, now known as Rule 17, guaranteed that the quality of the wood used for the curved, laminated arches would last the lifetime of the building. These unusual arches have maintained their integrity over the years.
